## Failure Analysis For Initiation Of Crack On Helical Pinion Shaft- A Review

**Abstract:** WAG means Wide gauge AC traction Goods duty. WAG-9 is the most powerful engines in the country yet. For time to time service consideration in passenger as well as goods transport, the efficiency as well as longer service life of system components are important factors. The component which has been study is obtained from the "Central Railway Electric Locomotive Workshop, Bhusawal, India." In the recent study, the premature failure of traction motor assembly in WAG-9 is carefully investigated. The various literatures has been carefully compared and reviewed to get a proper helical pinion shaft failure analysis. From these literature reviews, the main objective of this paper is to study various Shaft Failure Analysis and Methodologies to select the best method to find out and analysis the Initiation of crack on Pinion Shaft.

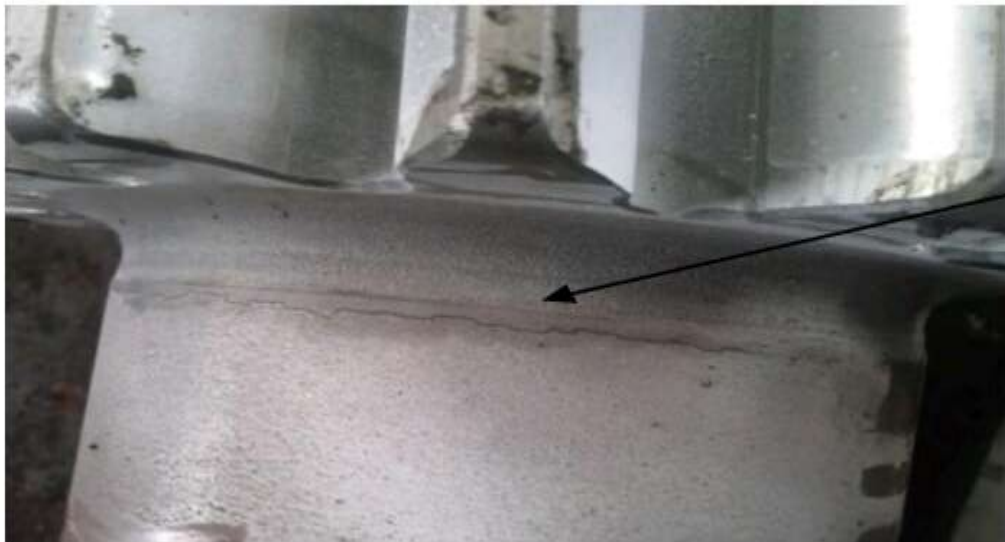
*Figure 2-Crack Detection*

- 1) Magnetic particle test: for performing the test, fluorescent powder mixed in liquid is spread over the pinion surface. Also at the same time pinion has been magnetized with proper instrument and high intensity ultraviolet light is focused on it. Then image obtained which is below shows some crack lining along the circumference of helical pinion shaft [1].
